Broken Rear Axle Repair

Small Adjustment Brings Big Improvement To Deere Combines

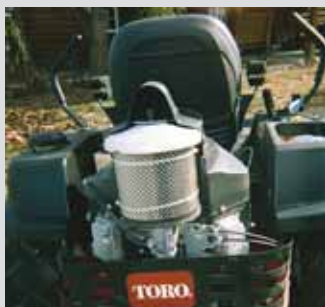
Rick Plunkett, Albany, Ky.: "When the air filter on my 2-year-old Toro 5060 zero-turn riding mower got dirty, I replaced it with a much bigger filter designed for a 20-gal. shop vac that I already had. The original filter was only about 4 in. long and a new one would have cost \$37, which I thought was ridiculous. A shop vac filter has much more capacity, and costs only about \$10. I think the same idea would work on any mower brand or model.

"I cut a piece of Lexan into a large circle to make a base for the filter, and cut a smaller hole in the middle to fit the air intake. To protect the filter I wrapped a section of metal gutter guard around it and secured it with plastic zip strips. I then installed a fine mesh metal screen over the carburetor intake and screwed the filter down on top of it.

"I used the lid off an aluminum cooking pan as a cover for the filter. I removed the handle and ran a long screw up through the filter's base and out through the pan lid, then put a plastic nut on it.

"I installed the big filter about a year ago and really like how it turned out. Whenever it gets dirty I just use a garden hose to clean it. I kept the original filter in case I ever decide to sell the mower."

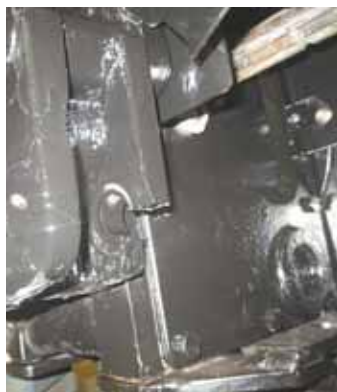
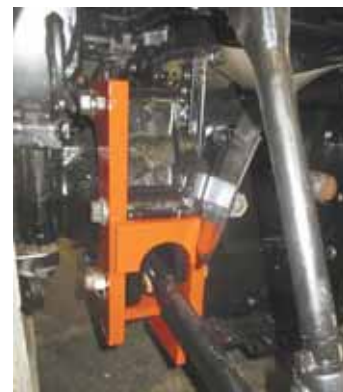
Bolt-on kit is designed to repair a broken rear axle housing on Deere 4000 series tractors. The problem happens when the pin hole for the 3-pt. lift arm breaks out of the axle housing.

Weaver's Compact Tractor in Shippensburg, Penn., specializes in parts for Ford, New Holland, and Deere compact diesel tractors. The company recently introduced its latest idea - a bolt-on kit to repair a broken rear axle housing on Deere 4000 series tractors.

The problem happens when the pin hole for the tractor's 3-pt. lift arm breaks out of the rear axle housing. "You just bolt the kit onto the housing using existing holes and go," says Jim Weaver. "There's no need to replace the expensive rear axle housing and

have the tractor spend hours of downtime in a shop for repairs. Just install the kit and hook up the existing 3-pt. lift arm and your tractor is ready to go back to work."
