WHAT DOES STRAIGHTENING COST? WHO PAYS THE BILL?

Setting Crooked Silos Straight

By Frank Buckingham

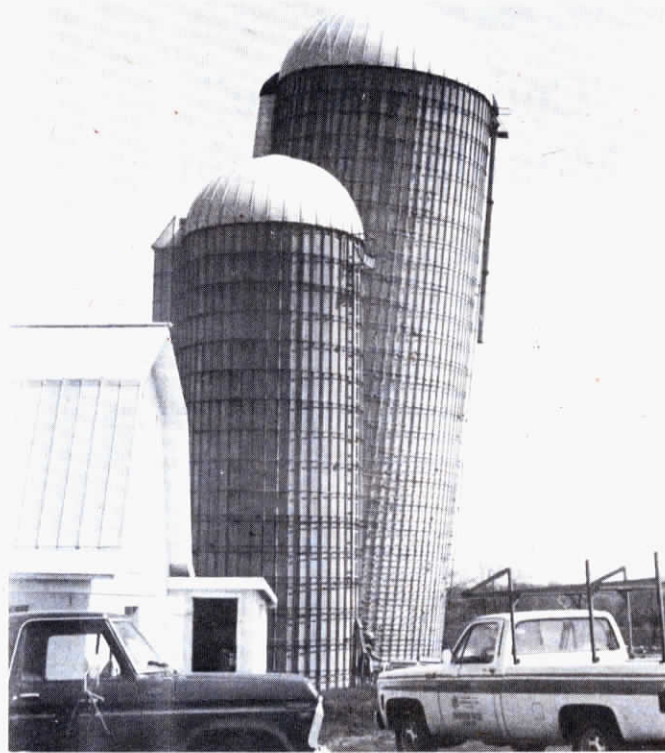
Pictured above is a "before" shot of the Denslow silo leaning a precarious 69 in.

The 24 by 65 ft. stave silo, built by another company, started leaning shortly after it was filled in the fall of 1978. "I called the company that built it and got no help whatsoever from them," says Ralph. "We spent the next 3 days unloading about 1/3 of the silage and this seemed to temporarily stop it from tilting any further. Over the next 18 months, we were able to empty it completely. The empty silo began to lean still more and we figured the only solution was to let it go, or have it taken down and rebuilt."

It was at this point that Stanek was called to the scene. When he arrived, the silo was tilting 69 in. Another 3 in. and it would topple. Afraid it might go, Denslow quickly removed the \$5,000 unloader inside so it wouldn't get busted up.

Stanek and his crew removed a ring of defective staves from around the base of the silo, then gradually lowered the 100 ton-structure 30 in., using ten 20-ton jacks.

Although 30 in. lower, the silo now

stands perfectly straight and was filled with silage last fall. Total cost to Denslow for having it straightened was right at \$8,000, not counting the labor involved to take the unloader out and put it back in, repairing the outside chute, and the many hours of time Denslow himself spent getting the problem resolved.

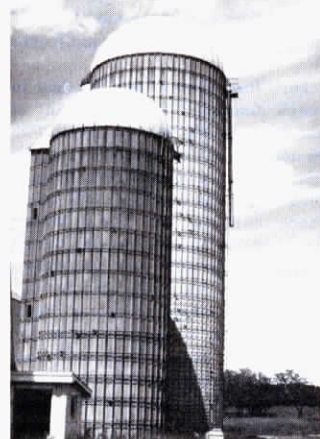
The results three days later of the straightening job provided by four experts from Madison Silo Co. Another company built the silo.
